# POWER LAKE PROJECT

## DAM REHABILITATION

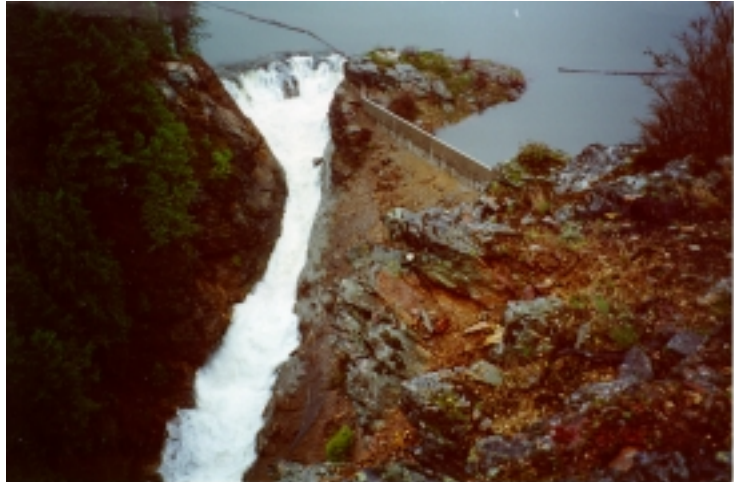
Power Lake Dam was constructed in the early 1920s to store water for the Pend Oreille PUD's 500 kW Calispell Hydroelectric Project. The dam is a 50-foot-high rockfill embankment and has a crest length of approximately 150 feet. The dam is flanked by steep rock abutments. The rockfill crest of the dam is 5 to 8 feet wide. The top of the concrete facing (parapet wall) is approximately 3 to 4 feet higher than the rockfill crest. The dam's spillway, located on the right rock abutment, is formed in a steep rock chute, which narrows to about 26 feet in width downstream from the crest.

Washington State Department of Ecology Dam Safety Section (DSS) calculated the design flood for Power Lake Dam and concluded that the spillway was inadequate for the flood, and that the flood would overtop the dam. DDS was also concerned that spillway flows were causing erosion at the toe of the dam. Two members of EES Consulting's staff participated in the Power Lake Dam Rehabilitation Project to bring the dam into compliance with Washington State Dam Safety criteria. The design objectives were to increase the spillway capacity; raise the dam height to prevent overtopping during flooding conditions; and protect the dam toe against erosion from spillway discharges. Work completed ranged from design and project management to permitting and construction oversight review.

Construction at Power Lake Dam began in June 1995 and was completed in 3 months. The work involved difficult excavation of approximately 1,000 cubic yards of rock to widen and deepen the spillway. Shotcrete was applied to the rock side walls to provide additional reinforcement. The dam was raised approximately 5 feet by anchoring a new concrete wall to the existing concrete dam facing. Riprap from the excavation was placed and grouted at the dam toe for erosion protection. All construction work was completed on schedule and within budget with no environmental problems.
